page 1 of 4 Test No.: 5294

Test Intention:In this test we want to investigate the lifespan of our new designed CF881.15.12 in an e-chain with a 125mm radius.

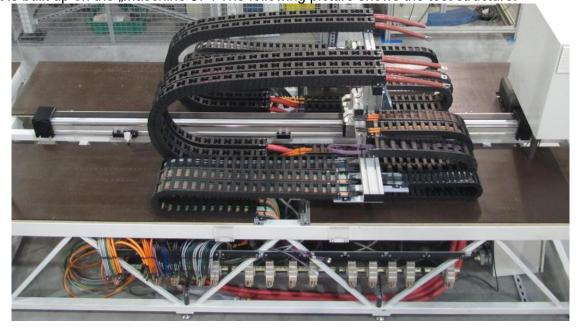
This test is built up on the "Maschine 57". The following picture shows the test structure:

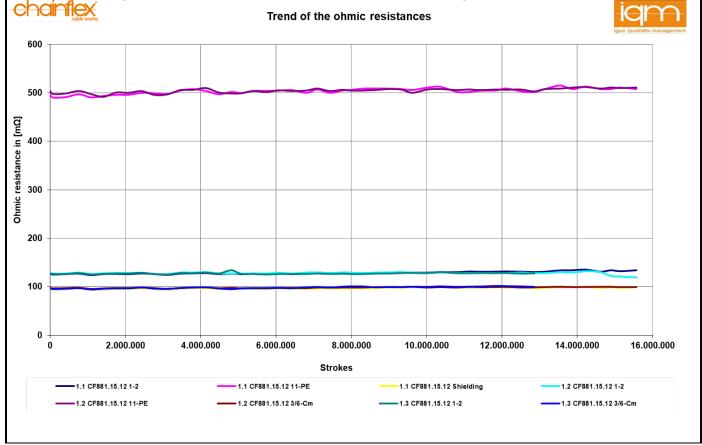
The following diagram shows the trend of the ohmic resistances during the test:

To detect broken conductor or shielding wires we will measure the ohmic resistance of these cable elements. The cores of the samples are connected in series and one core is connected with the shielding to measure the ohmic resistances.

At the 14.05.2018 we started the test 5294 at a counter reading of 62.744.582, we will measure the ohmic resistance regularly.

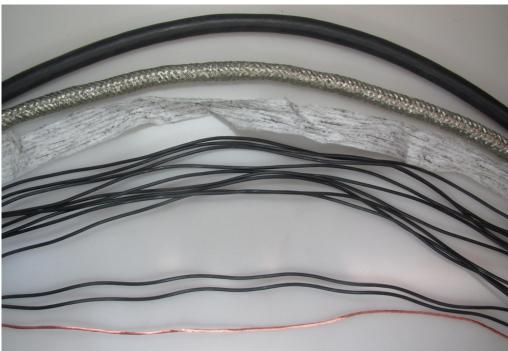
The following pictures show the dissected elements of the cables

The condition of the cable no. 1.3 (CF881.15.12) after 12.858.152 strokes

Strokes	12.858.152
Condition outer jacket	O.K.
Condition overall shielding	Single broken wires
Condition banding	O.K.
Condition core insulation	O.K.
Condition conductor	O.K.
